The Use of Integrated 2D Electrical Methods for the Investigation of Road Failure Along Ozalla-Uhonmora Road, Edo State, Nigeria

***Akhirevbulu O.E. & Salufu, S.O.**

Physics Department, Ambrose Alli University, Ekpoma, Nigeria

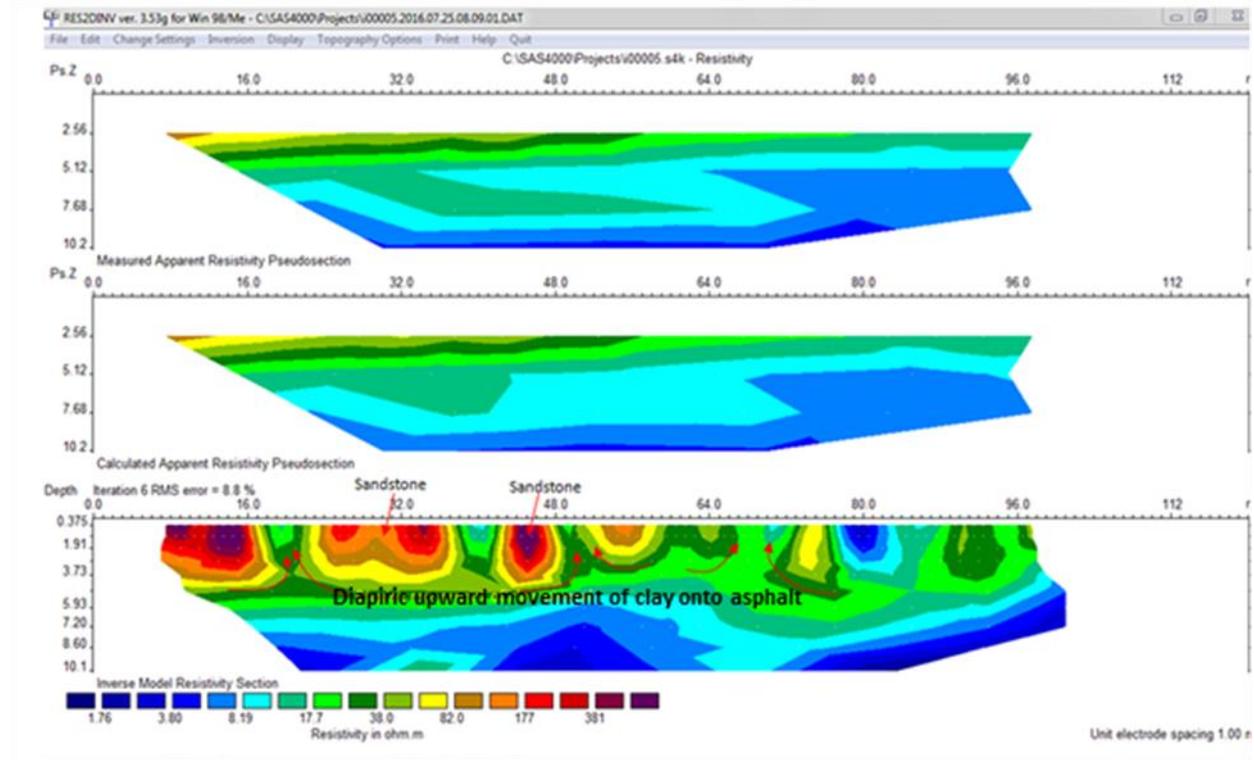
Fig.4: The result of 2D resistivity imaging acquired along Ozalla-Uhonmora failed road

Integrating the resistivity and IP interpreted results, couple with the background knowledge of the local geology of the study area, shows that the area is underlain with large thick layer of clay minerals that range in thickness from 7.1m to 10m (Fig.4) capped with a lateritic clayey sandstone layer of less than 3m at some point to a little over 3m (Fig.4) at some other point. The resistivity signature displayed in the 2D resistivity imaging result shows that red-purple colours are lateritic clayey sandstone, while green to dark green, blue, and grey colours represent clay beds (Fig.4). The structural nature, shape, and trend of colours signature of clay in the 2D resistivity imaging (Fig.4) represents piercing structure that is, severe movement of underlying clay upward into the overlying 3m sandstone thus, causing failure of the road portion of Ozalla-Uhonmora road in form of cracks, bulges depression and potholes. The IP result gives high values chargeability signature (Fig.5) indicating high presence of clay minerals that easily swell and

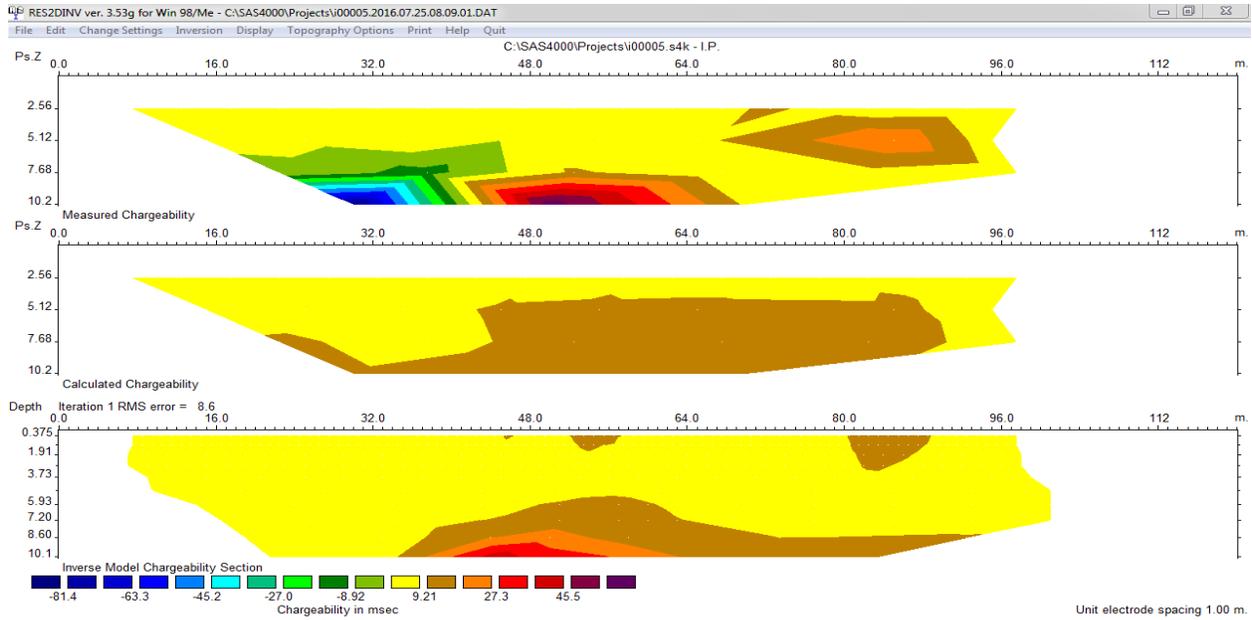
Fig.5: The result of 2D induced polarization imaging acquired along Ozalla-Uhonmora failed road.

expand. The IP result correlates well with the resistivity imaging result earlier showed. The dome shapes near the surface show very high chargeability values, this confirms that it is a swollen/expansion upward movement of clay material from beneath to the surface thus, causing crack (Fig.6a) and potholes (Fig.6b) of asphalt. The result of the 2D resistivity shows vividly clay diapir at 18-23m (Fig.4) and the upward piercing of clay thus forming bulge (Fig.6c) of the clay into the overlying asphalt on the road.

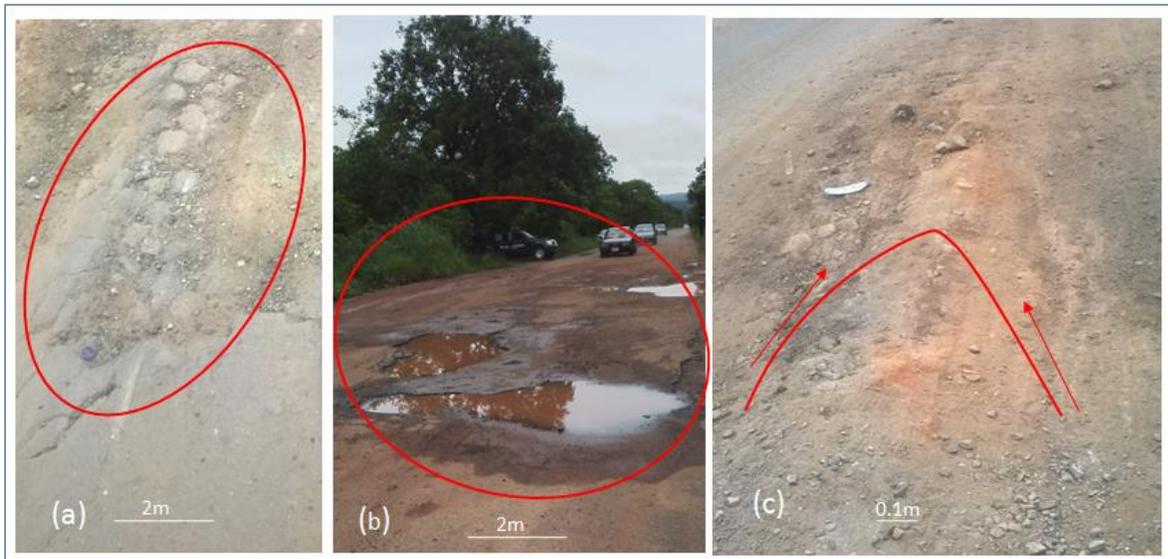
Fig.6: Failed portions of Ozalla-Uhonmora road. (a) appears as cracks, (b) appears as potholes, and (c) appears as bulge.

The saturation of the underlying clay minerals (montmorillonite), by rain water resulted into the swollen clay observed in the study area thus caused volumetric change in the bed rocks. Uneven daily loading of the foundation of the road by vehicular objects of varying sizes and weights, led to severe upward mass movement of the underlying swollen clay material into the overlying asphalt. These caused the clay diapiric deformation observed on the Ozalla-Uhonmora road.
