The Use of Integrated 2D Electrical Methods for the Investigation of Road Failure Along Ozalla-Uhonmora Road, Edo State, Nigeria

***Akhirevbulu O.E. & Salufu, S.O.**

Physics Department, Ambrose Alli University, Ekpoma, Nigeria

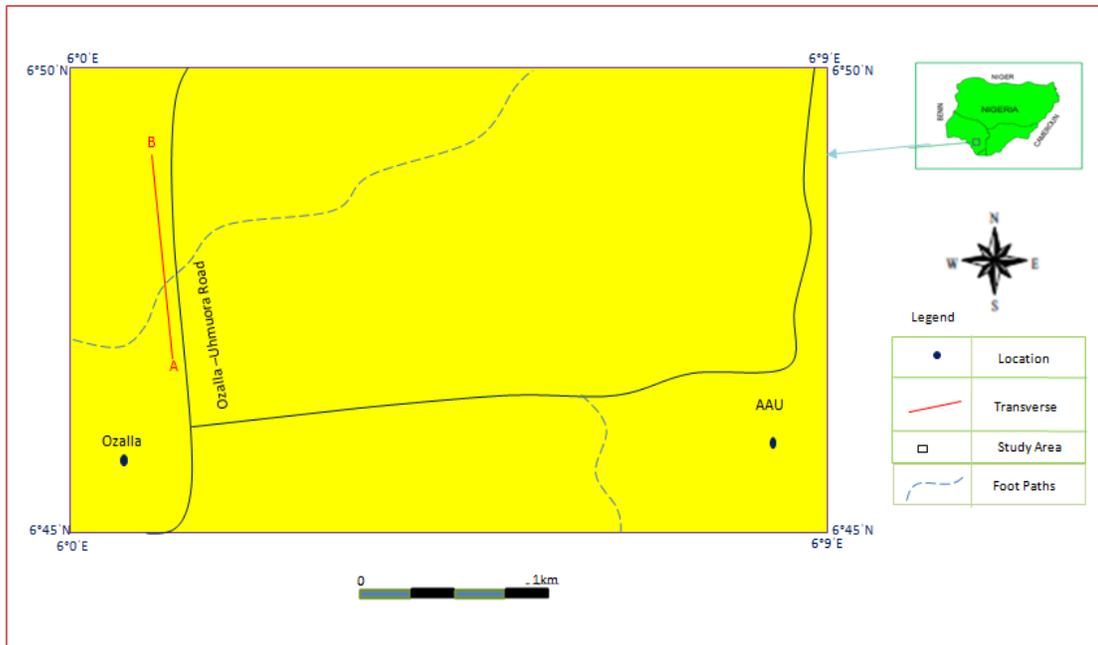
Fig.3: Transverse map showing a transverse line taken parallel to the failed road portion for data acquisition.

First, a geological investigation of the Ozalla-Uhonmora road was conducted. This was followed by an appraisal of the failed portions of the road (Fig.2). A transverse of about 120m (Fig.3) which run parallel to the failed portion of the road was taken. Along the transverse, the electrical resistivity and IP methods were employed simultaneously to acquire field data using the dipole-dipole arrays configuration because of the low E.M. coupling between the current and potential circuit. This was done to map vertical structures such as cavity, faults, diaper/piercing structures, so as to identify any cause of road failure arising from vertical geological structures and incompetent geological layers.
